**US Army Corps
of Engineers®**
Engineer Research and
Development Center

Evaluation of FloodWalls™ Flood Fighting Barrier¹

Donald L. Ward and Perry A. Taylor

January 2007

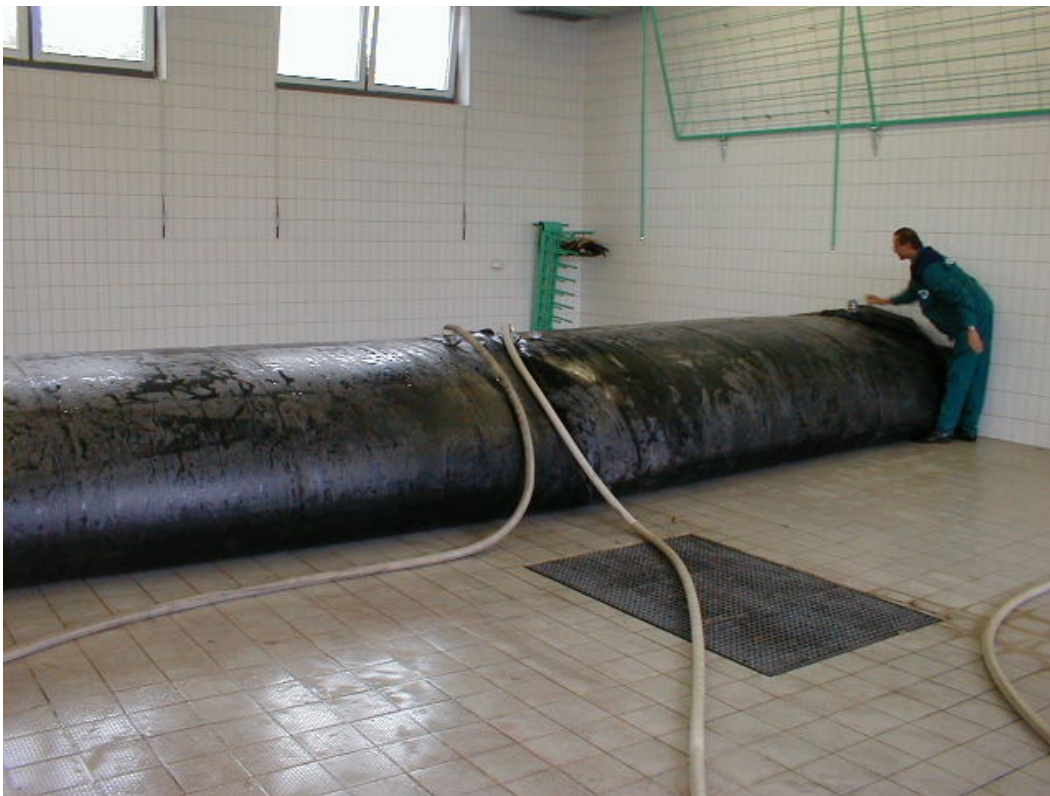
The Floodwalls™ units are large quasi-cylindrical bags made of a heavy-duty rubberized fabric (Figure 2). The units are manufactured in the Czech Republic by Rubrena Corp. and available in the US through FloodWalls, Inc.

Figure 2. FloodWalls™ flood fighting units (from www.floodwalls.com)

The units received for testing were identified as Type A units. Each bag was constructed with four ports for filling and emptying, two near the top of the bag and two near the bottom. Each port was fitted with a European quarter-turn quick-connect fitting, but other fittings are available. An adapter was provided to attach the quick-connect fitting to the end of a 1-1/2-in-diam water line.

A common problem with cylindrical water-inflated bags is that increasing water pressure from rising water on the pool side of the bags will cause the bags to roll away from the pool. To counter this effect, the FloodWalls™ units are constructed with two internal baffles that run the length of the units in the shape of an inverted "V." The baffles effectively prevent the units from rolling when flooded on one side.

Flaps at the ends of the units have grommet-reinforced holes that can be used to tie adjacent units together before filling as a protection against movement of the units.

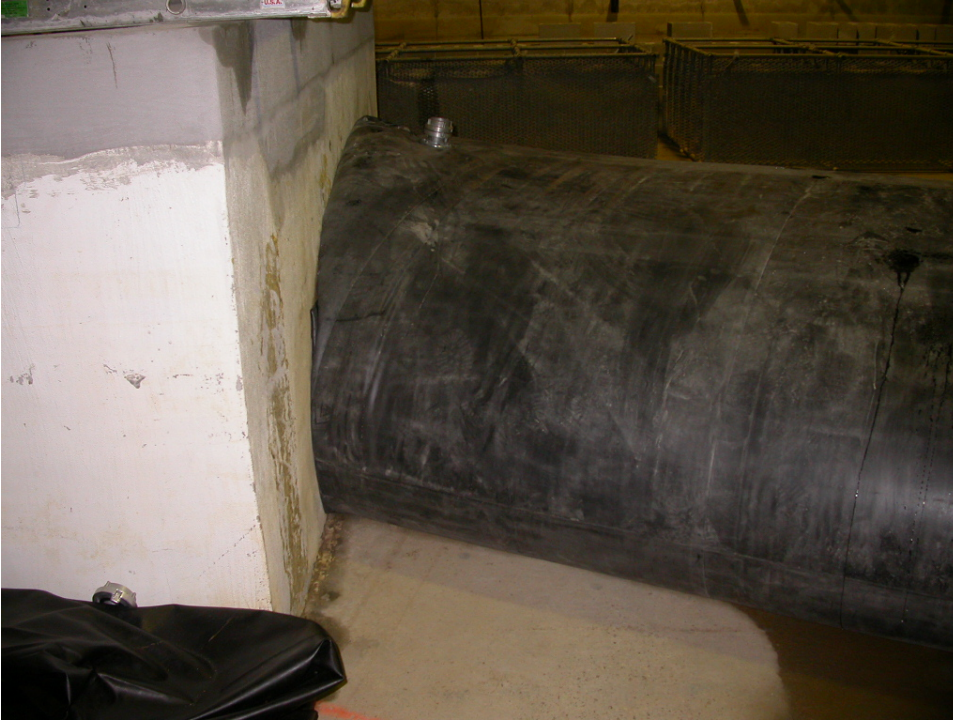
Figure 4. Unit A abutting the wingwall and showing one of the upper fill ports

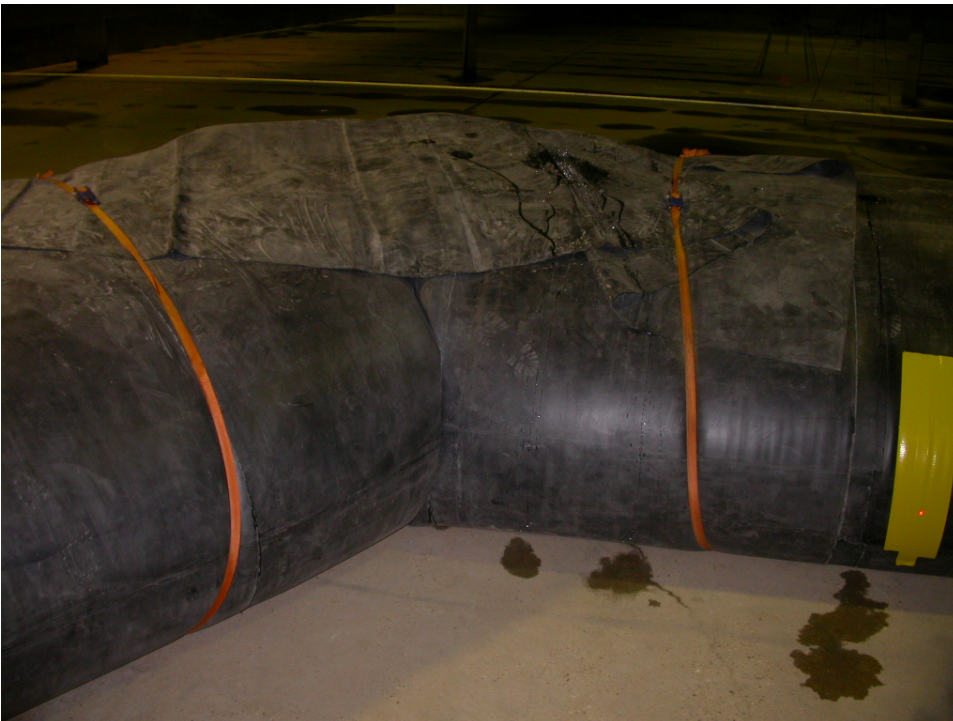
Figure 5. Corner at Units B and C

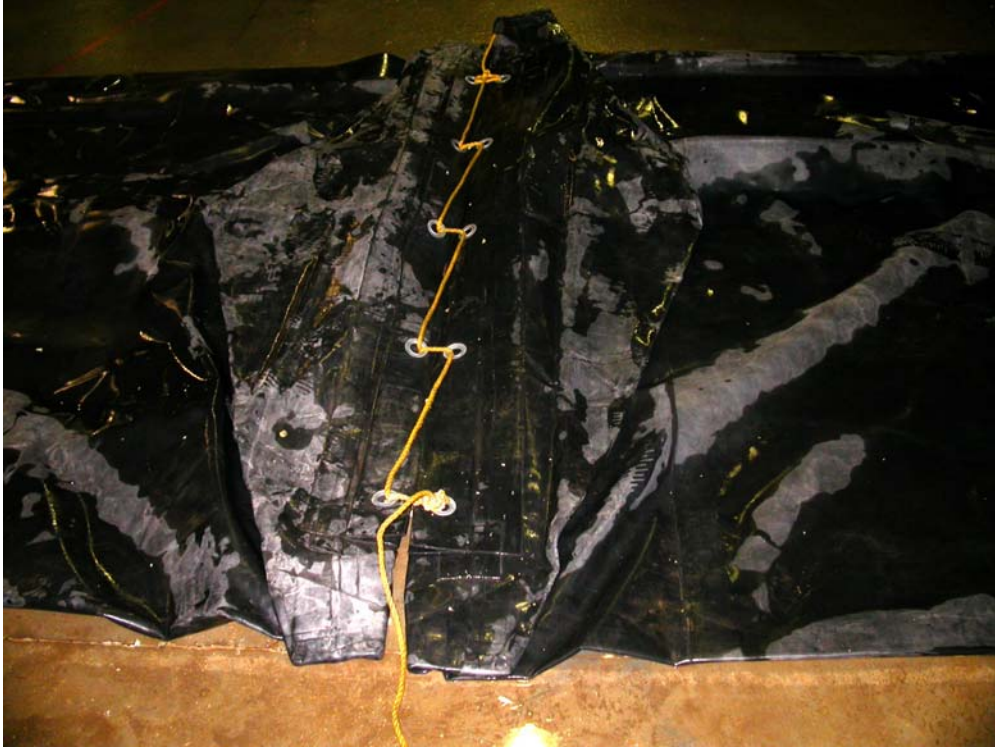
Unlike the previous the construction, the units for this test were tied together at the ends. Figure 76 shows the ends of two units tied together.

Figure 8. Two units tied together at their ends

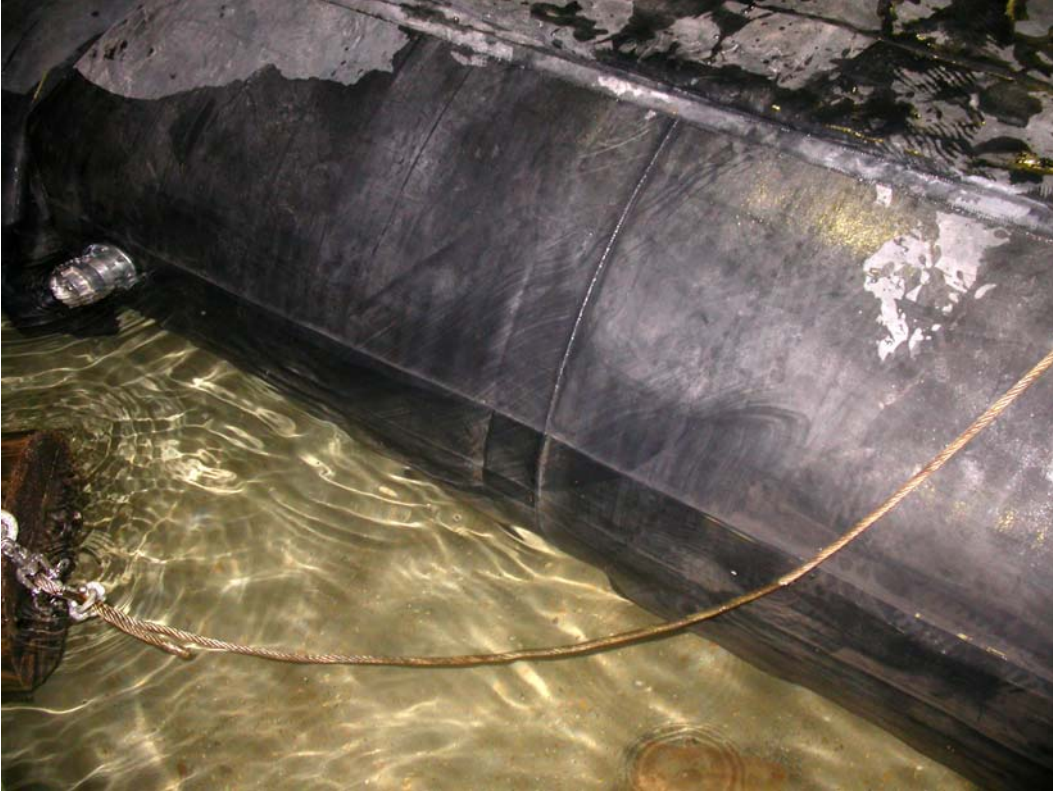
Both logs struck near the center of Unit B-2. The 12 in log left barely perceptible scratches on the fabric but caused no damage. Scratches left by the larger log were more noticeable, but again caused no damage. Figure 78 shows the 12 in log and impact location on Unit B-2.

Figure 9. Twelve in log and location of impact on Unit B-2

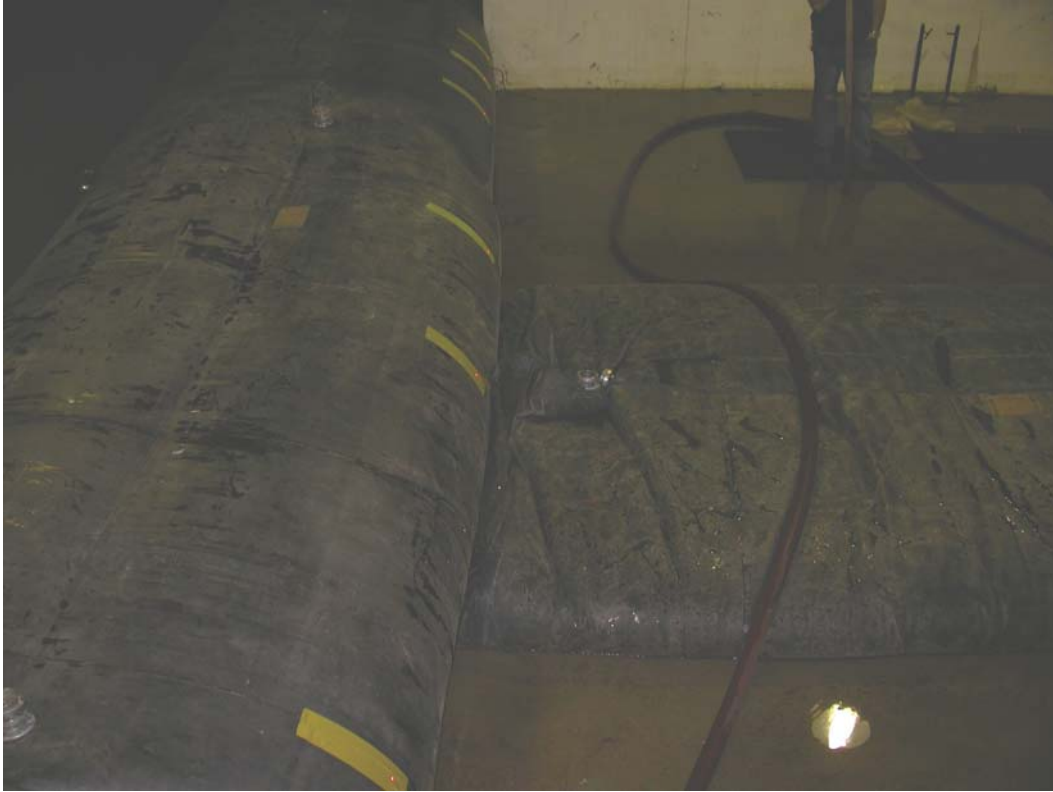
Although the testing protocol was completed, two additional tests were conducted to demonstrate the capabilities of the FloodWalls™ Barrier: a test with large waves and an overtopping test. For these additional tests an extra unit (E-2) was added to the units in Setup 2 as shown in Figures 87 and 88 to form a

wall.” Unit E-2 was not tied to the other units and was installed strictly as a freestanding unit to provide support to the front row of units.

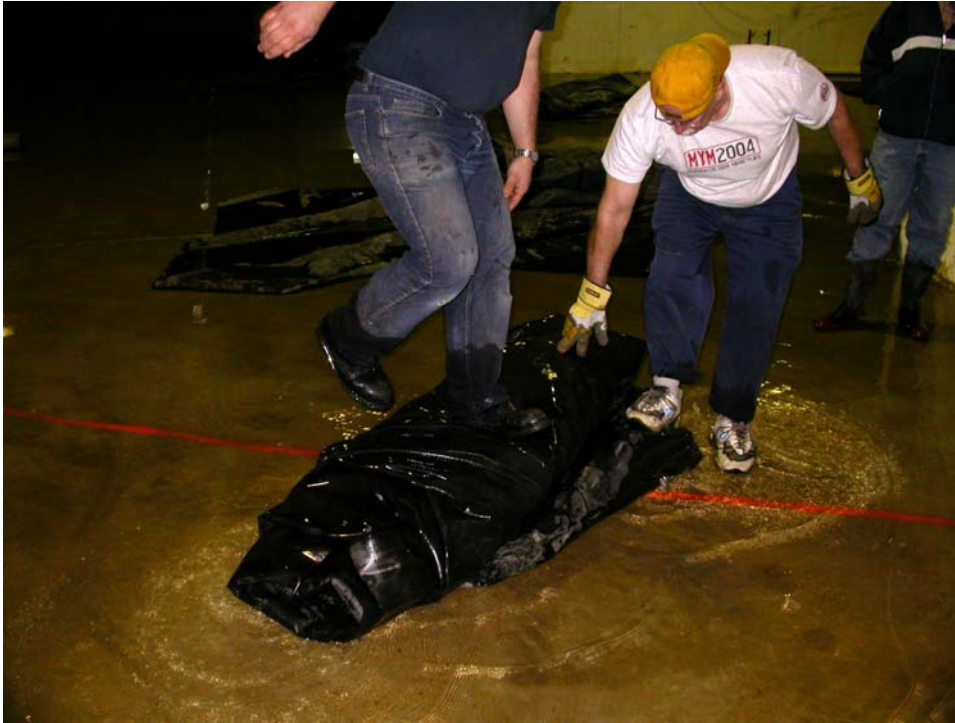
After opening the drain valves (Figure 109), it took 30 min for the units to empty. The bags were then folded and rolled to force additional water from them (Figure 110), then unrolled and unfolded, and refolded and rolled (Figure 111) for storage.

A small forklift (Prime Mover L1200) with driver was used to load the units into the shipping crates. A total of 8 units were packed, including 3 units that were not used in this test series. As the units were being packed, it was decided to hang a unit vertically from the Prime Mover to try and further drain the unit and reduce the weight for shipping (Figures 112 and 113). Using the Prime Mover to further drain the units worked well, and six of the units were unrolled, hung by the Prime Mover, and then re-rolled and crated.
